# THE IMPACT OF THE KAKHOVKA DAM DESTRUCTION ON THE WATER TEMPERATURE IN THE LOWER REACHES OF THE DNIPRO RIVER AND THE FORMER KAKHOVSKE RESERVOIR

The results of the studies devoted to the consequences of the Kakhovka dam destruction and the emptying of the Kakhovske reservoir are presented. The water regime of the lower reaches of the Dnipro River was studied, in particular, the water temperature. The remote sensing data on spatial features of water temperature are given. Significant changes in water temperature are shown both in the lower reaches of the Dnipro River and in the former Kakhovske reservoir. In the first days after the destruction of the dam, due to the mixing, the surface water temperature at the mouth of the Dnipro River dropped significantly. Then the water temperature in the lower reaches of the river approached to that one observed before the destruction. In turn, the former Kakhovske reservoir became a network of river branches and lakes that cannot be compared with the former reservoir. The Dniprovske Reservoir, located upstream, affects the water temperature of this territory, especially the largest branch.

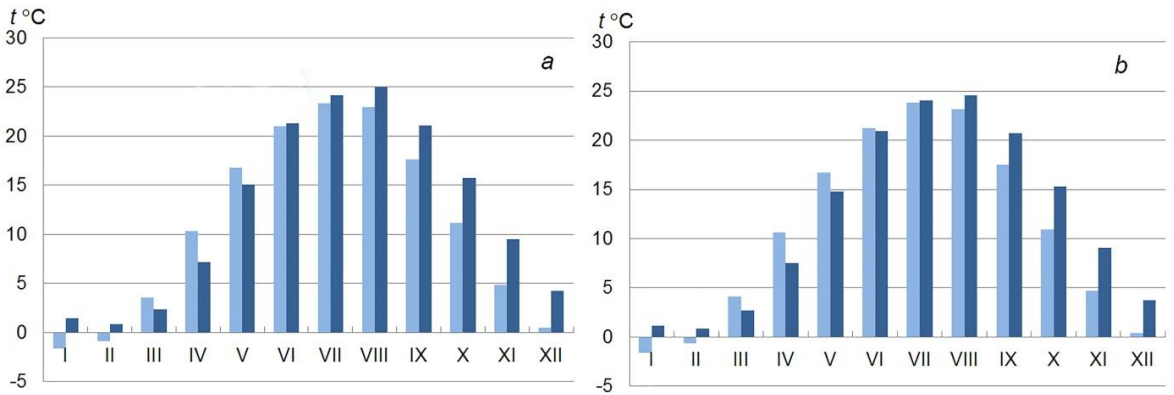
**Fig. 2: Mean monthly air temperature (left columns) and mean monthly water temperature (right columns) during 1991–2020 at Nova Kakovka (a) and Kherson (b)**

The water temperature at Nova Kakhovka station depended on the large volume of former Kakhovske reservoir which heating and cooling was very slow. The water temperature at this station also depended on the reservoirs located upstream. As noted, upstream the Kakhovske reservoir exists the very deep Dniprovskoe one. Besides, there are four more reservoirs. As a result, the water temperature in the Kakhovske reservoir in spring was much colder than air temperature. Another peculiarity was observed in autumn, when the water temperature was much warmer, than air temperature. The mean air temperature at Nova Kakhovka station in October during 1991–2020 was 11.4 °C and the mean water temperature was 15.7 °C (Fig. 2).

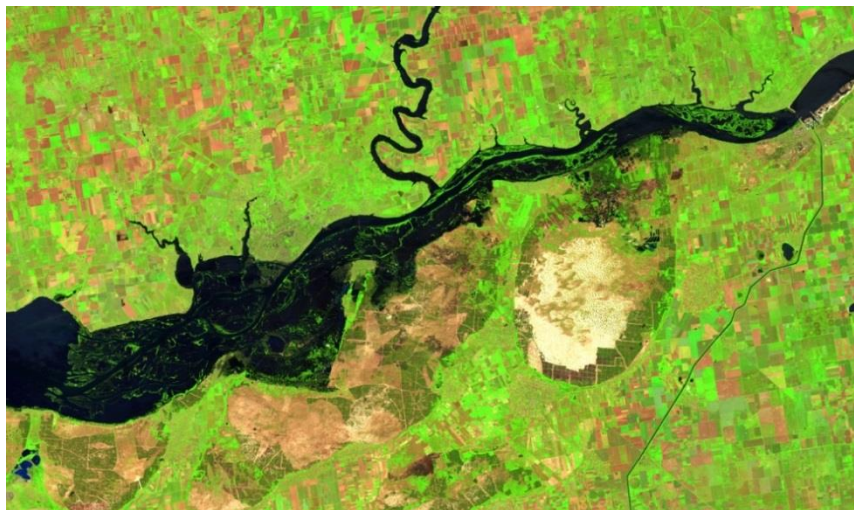
**Fig. 4: The satellite images of the lower reaches of the Dnipro River taken by Landsat 8 satellite: a – on June 01, 2023, b – on June 09, 2023**

Soon after explosion, the large territory along the both banks of the Dnipro River downstream the Kakhovka dam was flooded. Four cities and more than dozen villages were flooded (Fig. 4).

As can be seen in Fig. 4, the increase of water level was observed not only in the lower reaches of the Dnipro River, but also on its right tributary, the Inhulets River. The increase of water level reached there several meters. Many consequences of this accident, including the pollution of water, are described in papers (Gleick *et al.*, 2023; Vyshnevskiy *et al.*, 2023; Vyshnevskiy & Shevchuk, 2024).

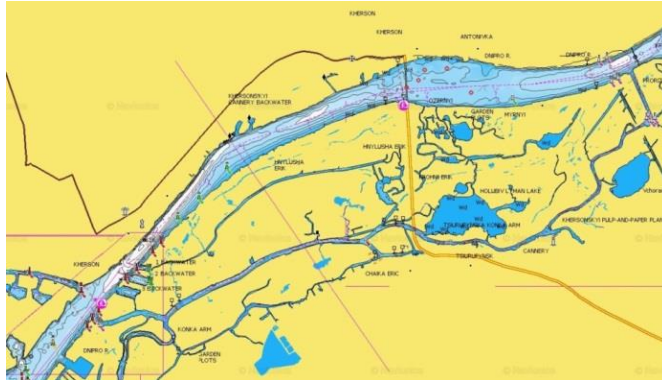
**Fig. 8: The fragment of navigation map of the Dnipro River near and upstream Kherson city (a) and the water temperature in this section on 20.08.2023 (b)**

The observed feature can be explained by the different water mixing, which is due to the peculiarities of the river channel. The river depth in the two above mentioned narrow places with high temperature reaches 17–20 m. At the same time, the depth of the wide sections is only 6–7 m (Fig. 8).
