# NATURAL PROCESSES IN THE AREA OF THE FORMER KAKHOVSKE RESERVOIR AFTER THE DESTRUCTION OF THE KAKHOVKA HPP

## ABSTRACT

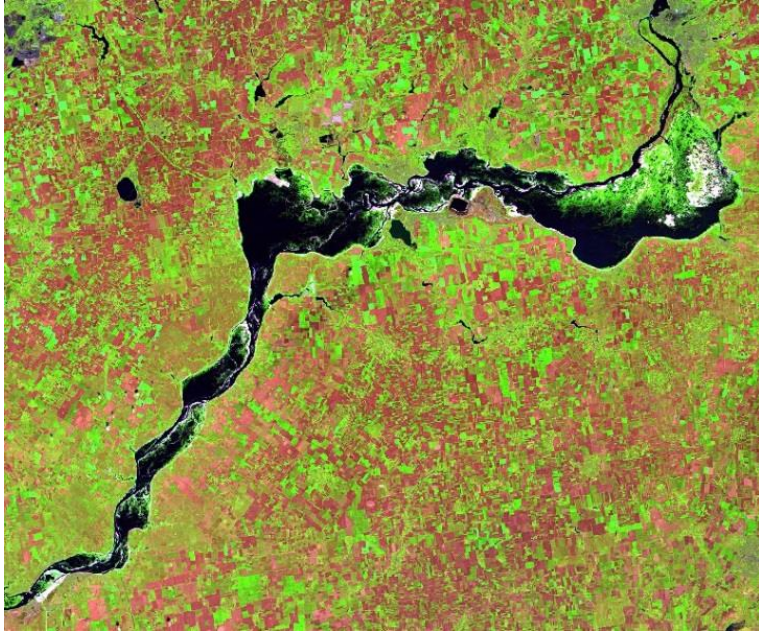
The available satellite images show that in the spring of 2024, more than two thirds of the former reservoir area was covered by water. This can be seen on the satellite images taken on April 30, 2024. At that time, the water level at Rozumivka station was 14.35 m a.s.l. (Fig. 7).

**Fig. 7:** Satellite image of Sentinel 2 satellite taken on April 30, 2024, which shows the flooding area on the territory of the former Kakhovske reservoir during the spring flood

The water level a few days earlier than on April 21 and on April 23, 2024 was higher – 14.62 m a.s.l. This means, that maximum inundation in the spring time of 2024 was larger, than it is shown in Fig. 7.

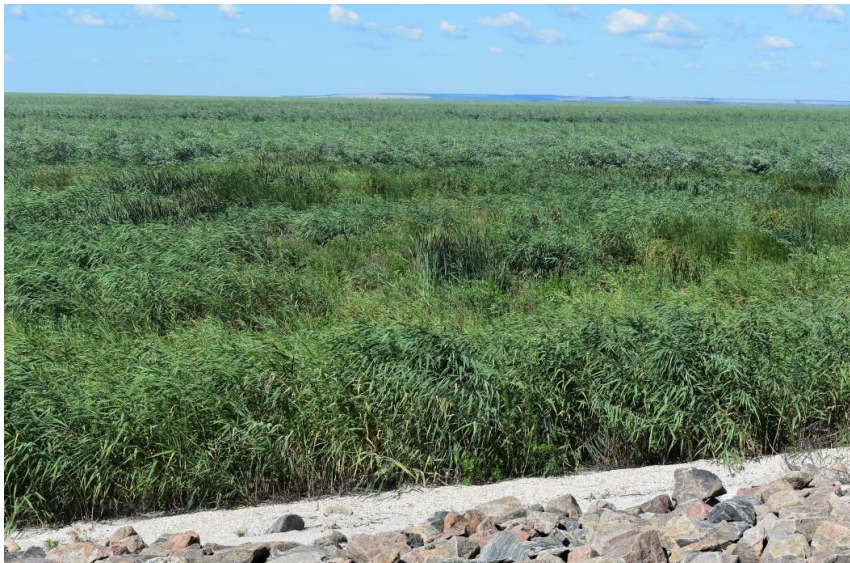
The shore near the village of Malokaterinivka has a stone protection. The adjacent strip of shore is covered with sandy deposits. Alongside, a strip of reed (*Phragmites australis*) is located, and finally, a large area of the former reservoir is covered with willow, more precisely a hybrid of *Salix alba* and *Salix fragilis* (Fig. 9).

**Fig. 9: The overall view of the former Kakhovske reservoir near the village of Malokaterynivka, 21.06.2024**

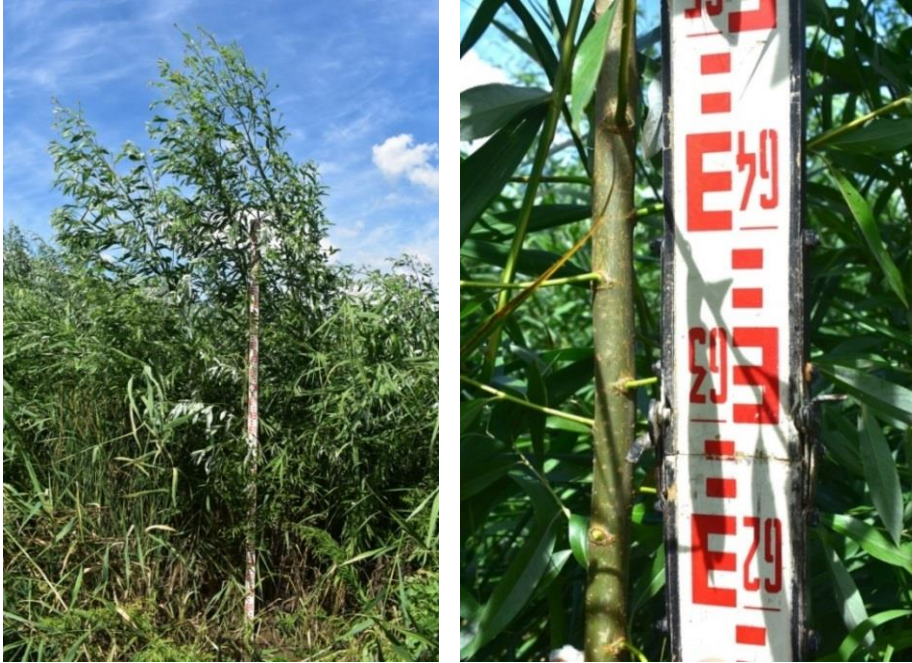
The height of the willow trees were measured using a 3 m long leveling rod. Taking into account the age of the trees (about a year), the mean height of the trees turned out to be enormous – about 4.5 m. The diameter of the trees at a height of 1.5 m was about 25 mm. The quantity of willows reached 30–40 per 1 m<sup>2</sup> (Fig. 10).

**Fig. 10: The typical size of willow trees near the village of Malokaterynivka, 21.06.2024**

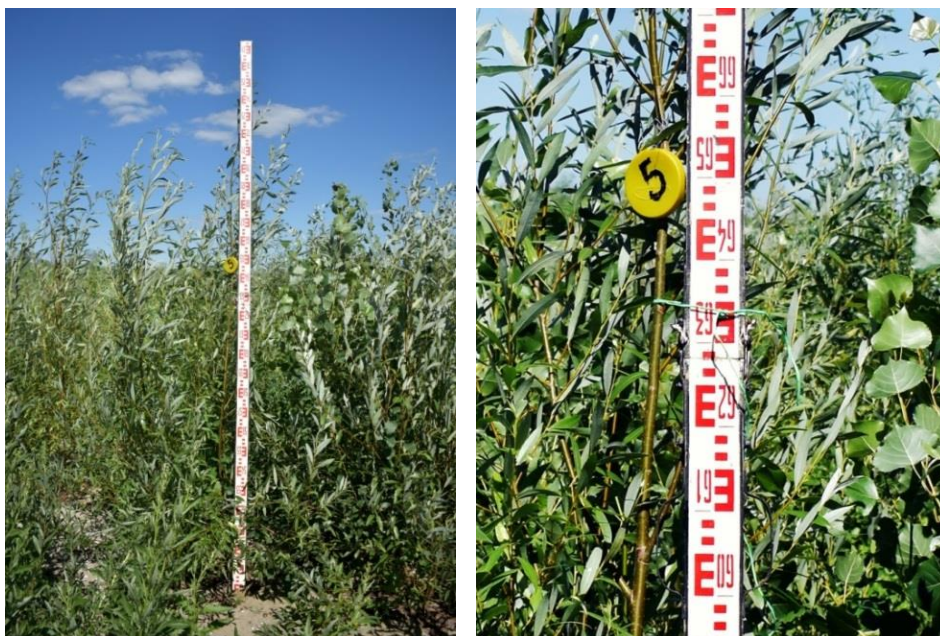
The size of the willows on the opposite right bank of the former reservoir on June 21, 2024 was much smaller. The average height of the trees was 2.7 m, the mean diameter at a height of 1.5 m was 13 mm. Poplar trees (*Populus nigra*) were also found in this area (Fig. 11).

**Fig. 11: The typical size of willow trees near the village of Bilenke, 21.06.2024**

Such differences of typical size of trees can be explained by differences in bottom sediments. The trees near the village of Bilenke began to grow on sandy sediments which were well washed by the river flow before the emptying of the reservoir.

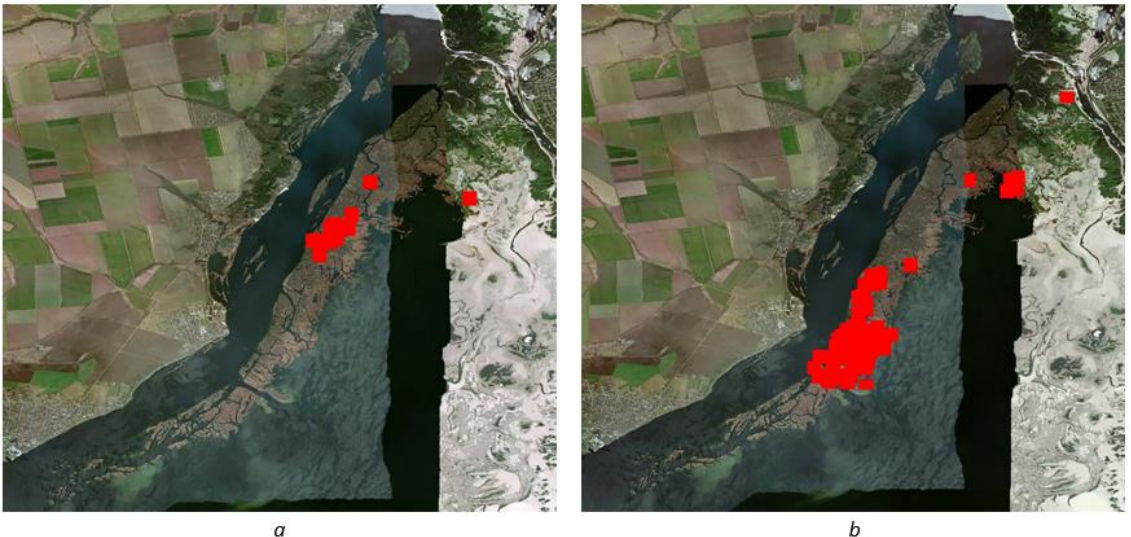
Some effect on the studied area has the war activity. Now, the former reservoir is the border between the Ukrainian and the Russian troops. Therefore, the shelling and the wildfires are possible on this area. In fact, the wildfires near and even inside the former Kakhovske reservoir started. These wildfires can be seen using Fire Information for Resource Management System (Fig. 12).

**Fig. 12: The wildfires in the upper part of the former Kakhovske reservoir according to data of FIRMS: *a* – on July 27, 2024, *b* – on August 19, 2024**

In particular, long-term wildfires in the area shown in Fig. 12, lasted from July 9 to July 14, 2024, from July 26 to July 30, 2024, from August 16 to August 21, 2024. In fact, such wildfires were observed in other part of the dried shore of the former reservoir.
